Title:	BCR Bad Reading at Transfer Station			ID:
				0010
Date in:	Response:	Model:	Author:	
2006-08-14	2006-08-14	-	CMa

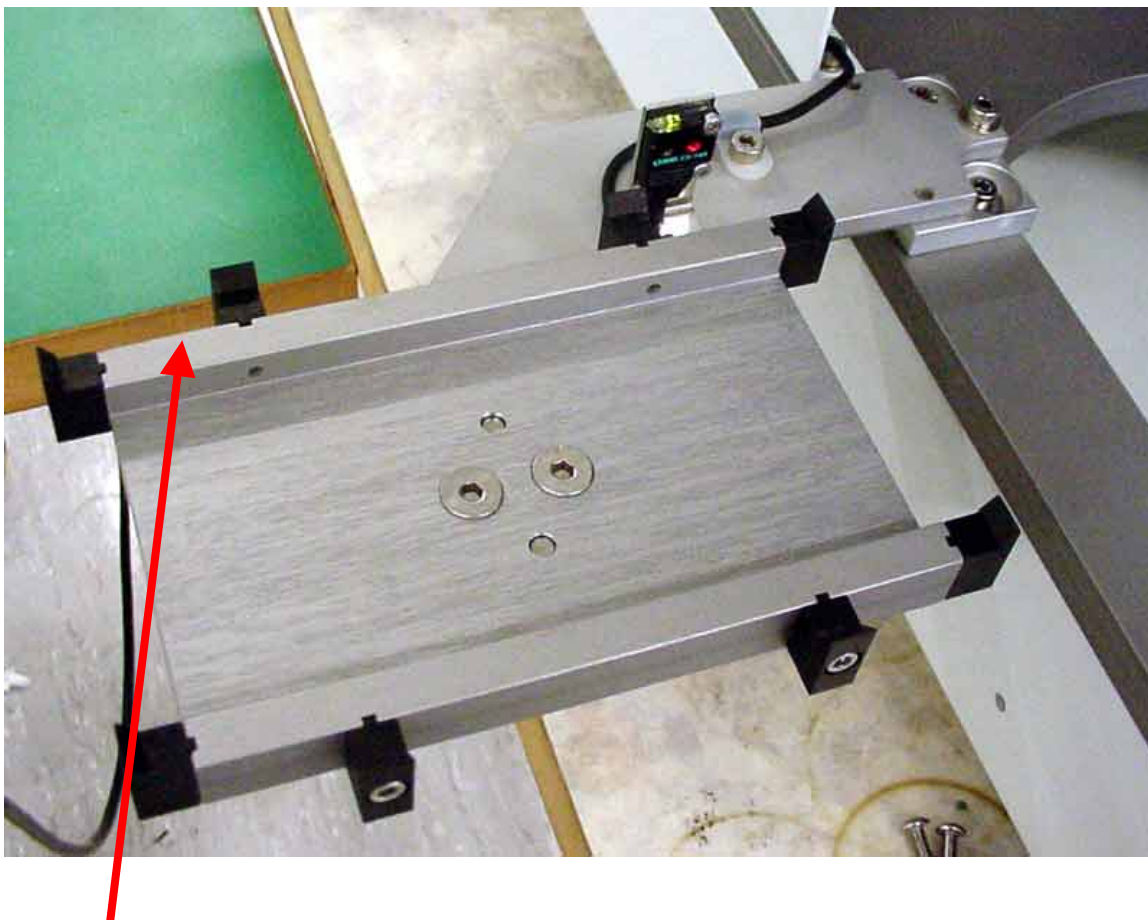
On clear plates there could be interferences between the BCR and the plate detection sensor of the transfer station.

Please have the sensor placed in the location of the Arrow, this is what I did for Astra on the STX 1000 to eliminate the reading of the BCR issue at the transfer station
