Title:	Carrousel Connector Layout			ID:
				0021
Date in:	Response:	Model:	Author:	
2004-06-29	2004-06-29	STX200	CMa

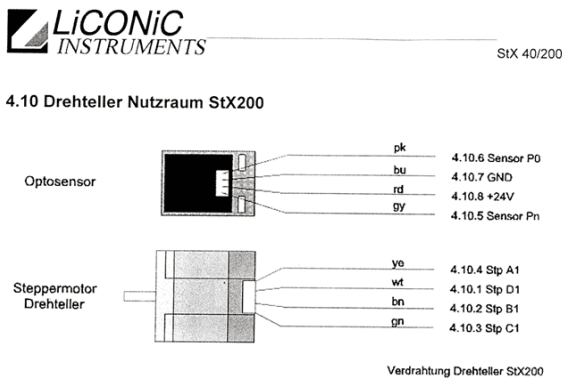
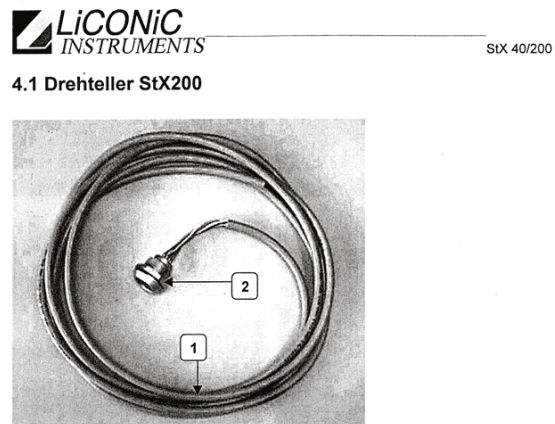
We have a problem with the carrousel positioning. Can you send me a wiring diagram?

Kabeldefinition

Pos	Name	Stk/Dim	Bezeichnung	Lieferant	Art-Nr.
1		2500mm	Kabel 8x0.5		
2	4.1		Buchse Lemo 8polig ERA.2E

Kabelbelegung

Stecker/Pin	Farbe/Nr.	Kabel Pos	Bezeichnung	Stecker/Pin
4.1.1	wt	1	Stepper D1	1.1.10
4.1.2	bn	1	Stepper B1	1.1.9
4.1.3	gn	1	Stepper C1	1.1.8
4.1.4	ye	1	Stepper A1	1.1.7
4.1.5	gy	1	Sensor Pn	1.1.2
4.1.6	pk	1	Sensor P0	1.1.1
4.1.7	bu	1	Sensor GND	1.1.5
4.1.8	rd	1	Sensor +24V	1.1.3
